## CHAPTER 6 CONCLUSIONS

## Tulelake Irrigation District - The First

**Tulelake Irrigation District  
Exposed 45-mil EPDM Geomembrane**

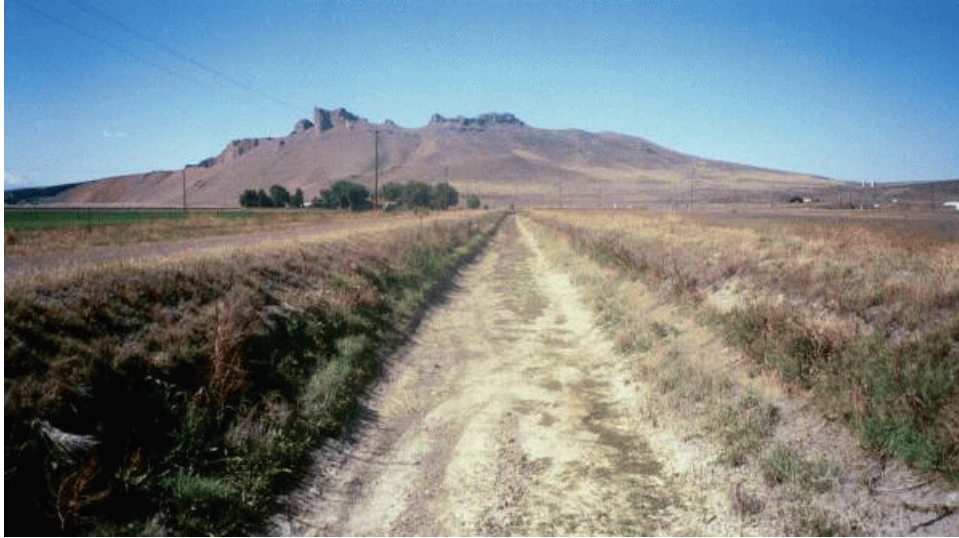
Photograph 1.—M-2 Lateral before lining.

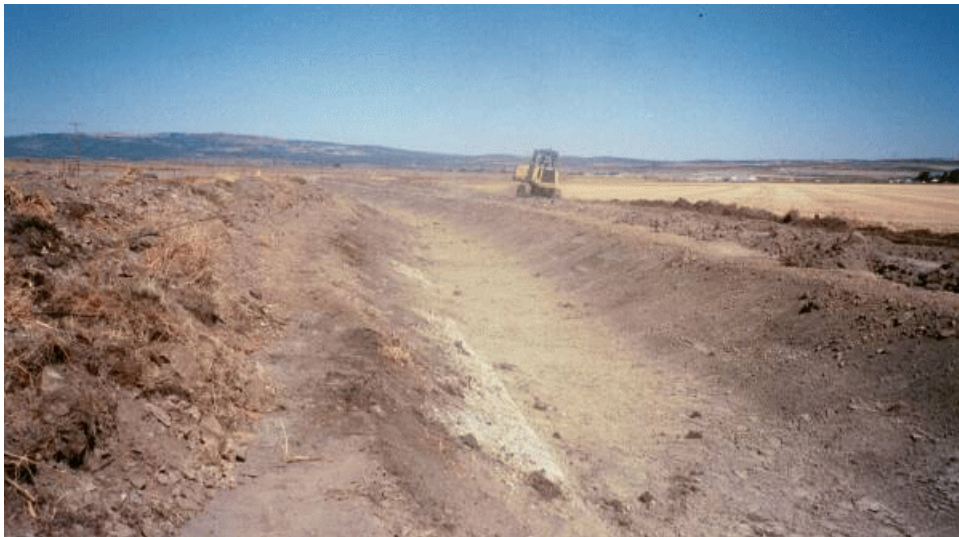
Photograph 2.—M-2 Lateral after shaping.

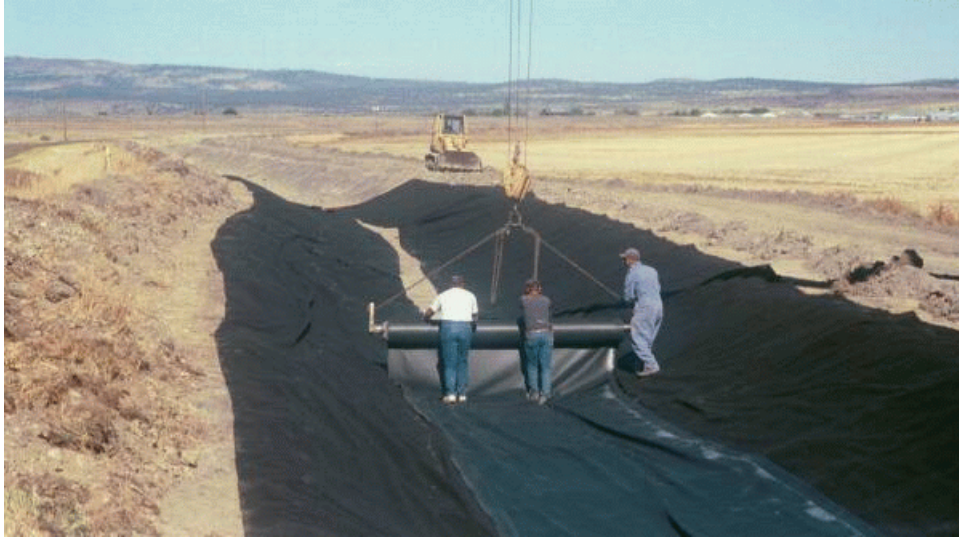
Photograph 3.—Geotextile in place and the geomembrane being place over it.

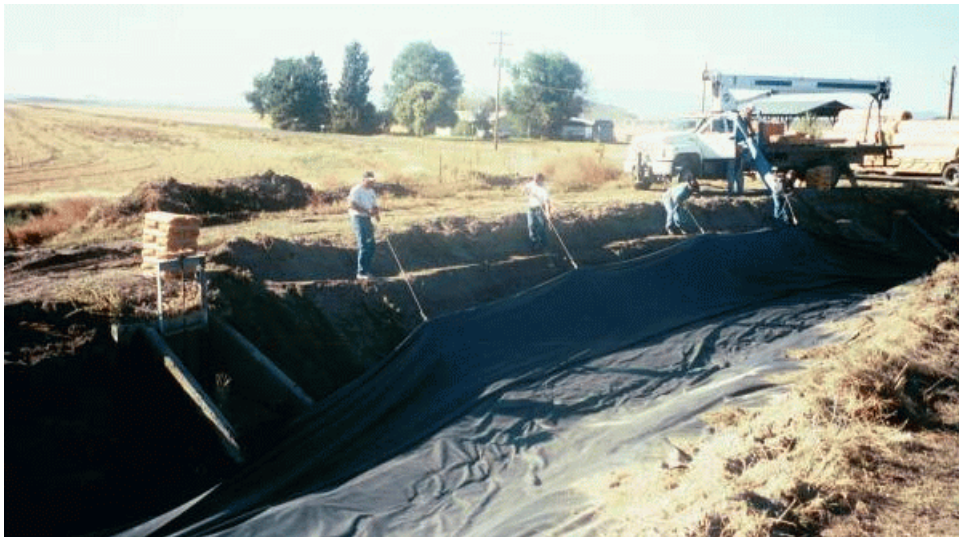
Photograph 4.—Tulelake Irrigation District personnel pulling the lining material up the side slope.

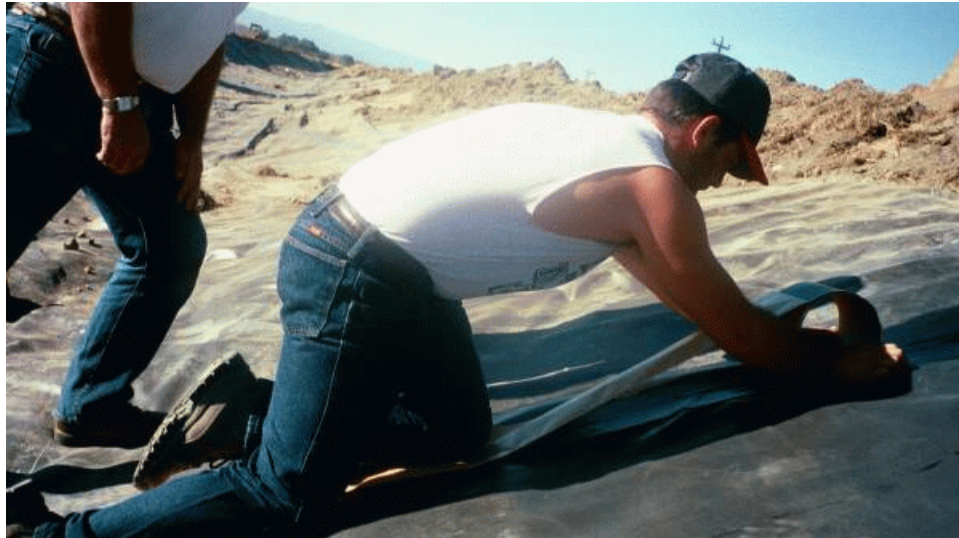
Photograph 5.—T.I.D. personnel seaming the panels using a solvent and a 6-inch wide tape.

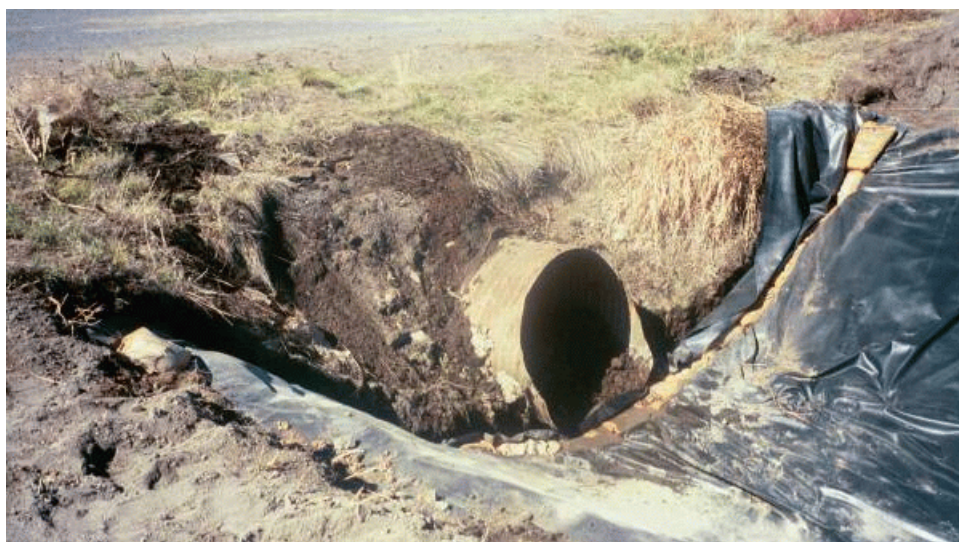
Photograph 6.—View of one of the cutoff trenches. Concrete was placed in the trench dry. As water gets in the bag, the concrete hardens and acts as an anchor.

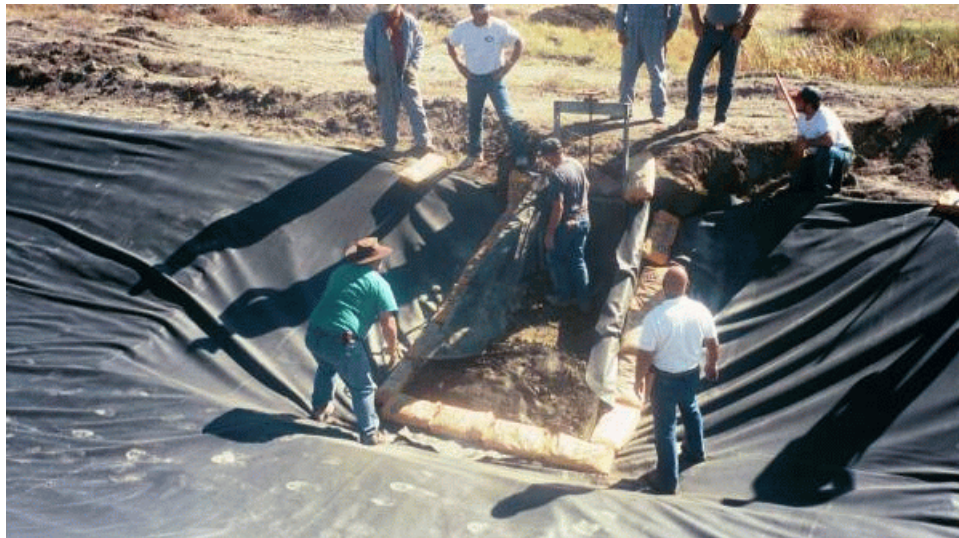
Photograph 7.—View of the cutoff ditch around a turnout structure. The same procedure was used here as in photograph 6.

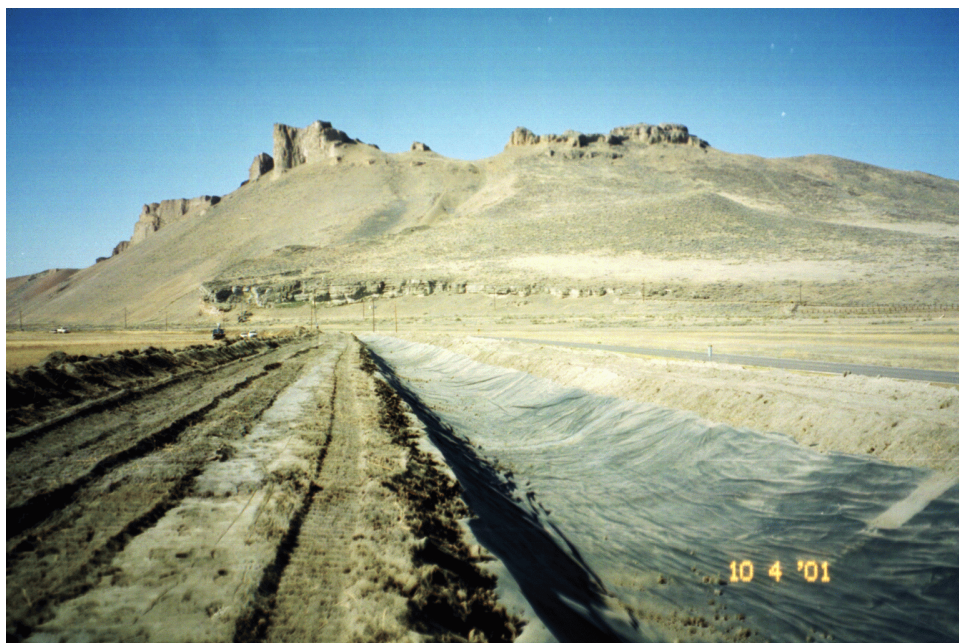
Photograph 8.—Completed geomembrane installation.
